## **Rural Municipality of East St. Paul Bottomley Creek Bank Remediation and Permanent Dike Construction Update - June 25th to July 1st, 2017**

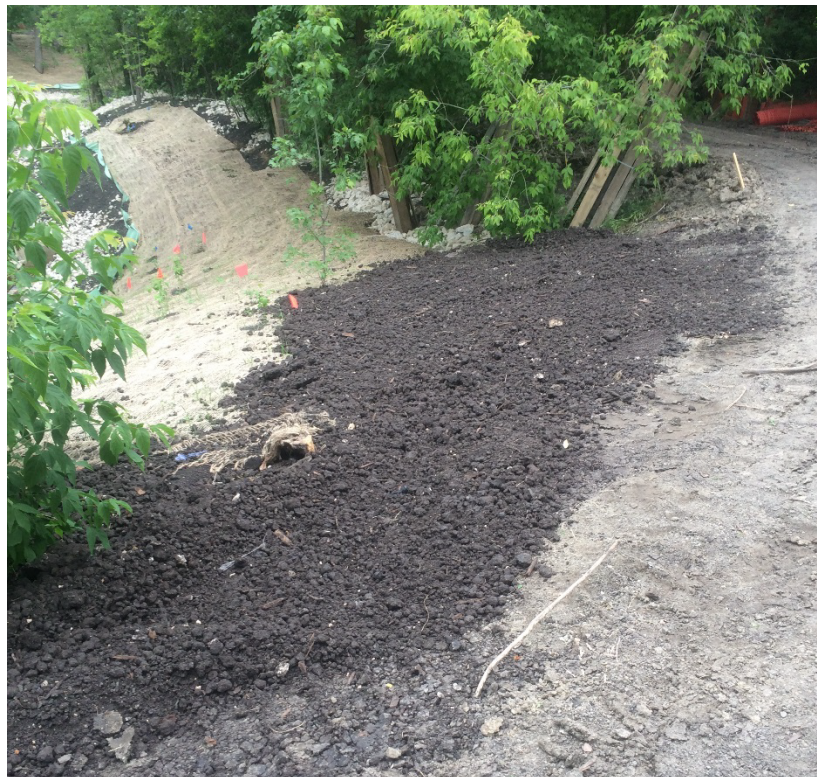
**Photo 1 - Topsoil placed on rockfill toe berm at 3144 Henderson Highway.**

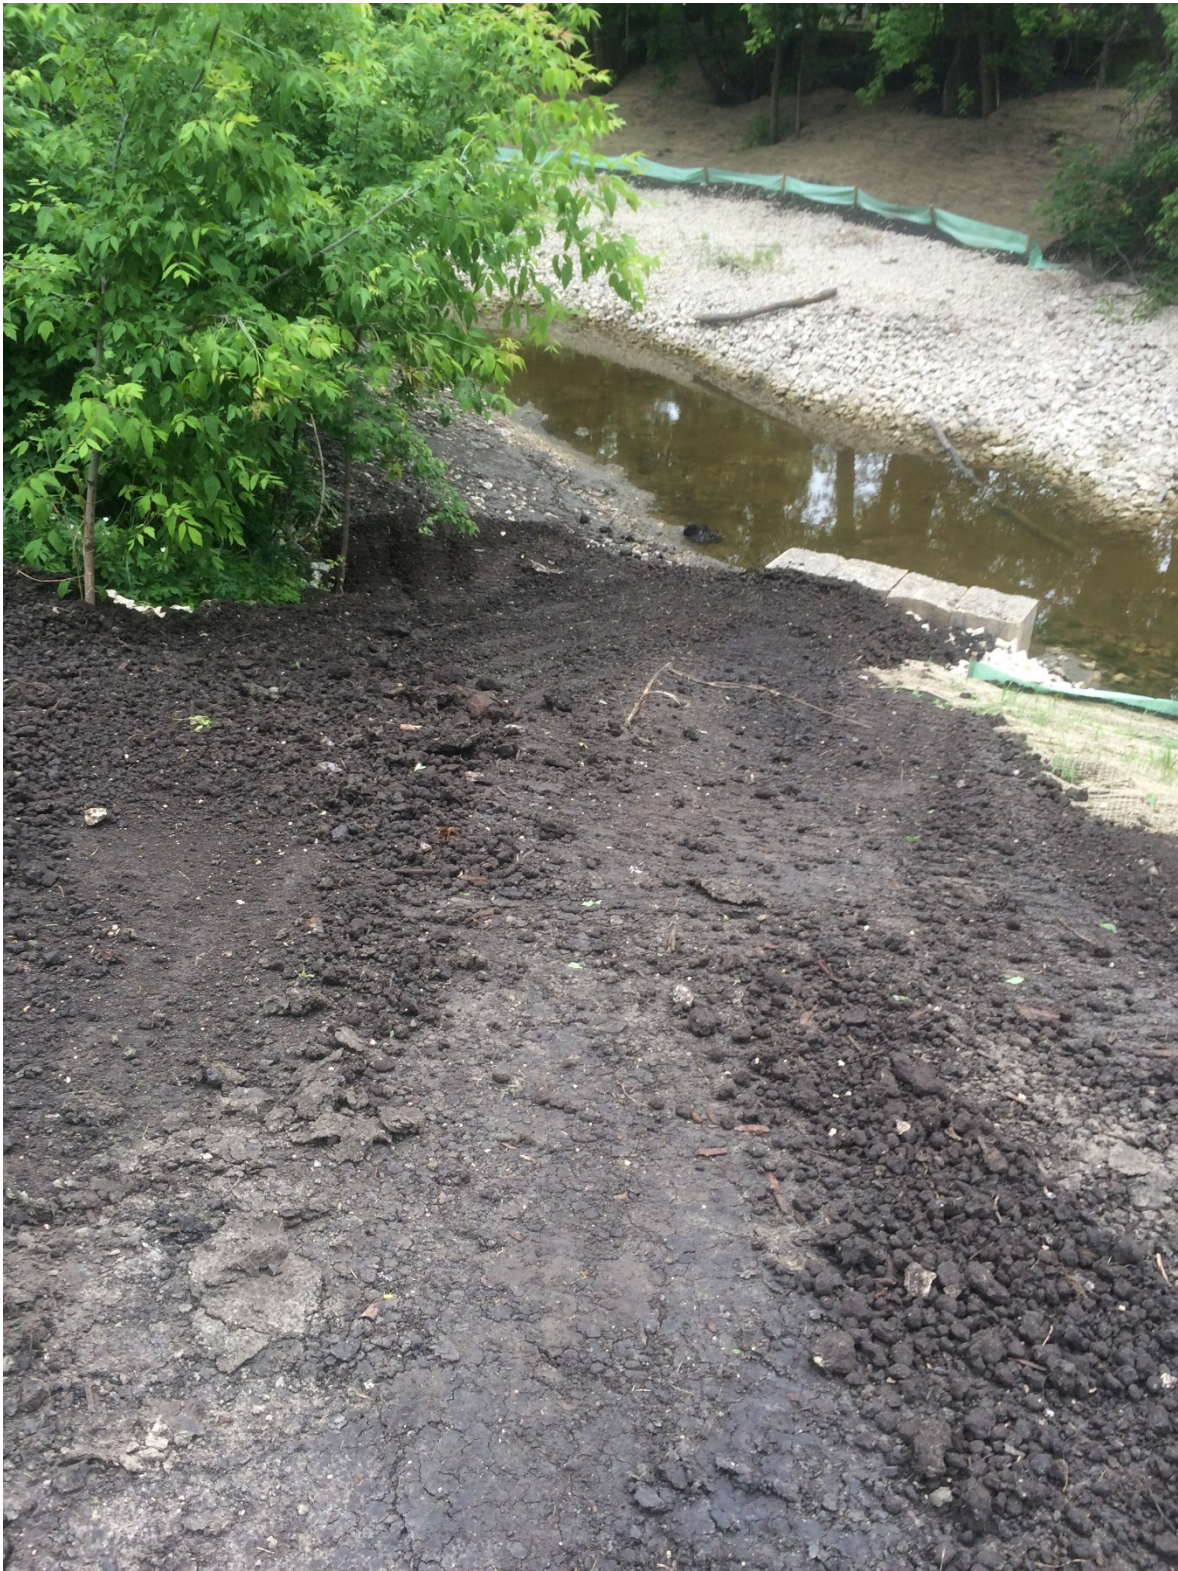
**Photo 2 - Topsoil placed on rockfill toe berm at 3144 Henderson Highway.**

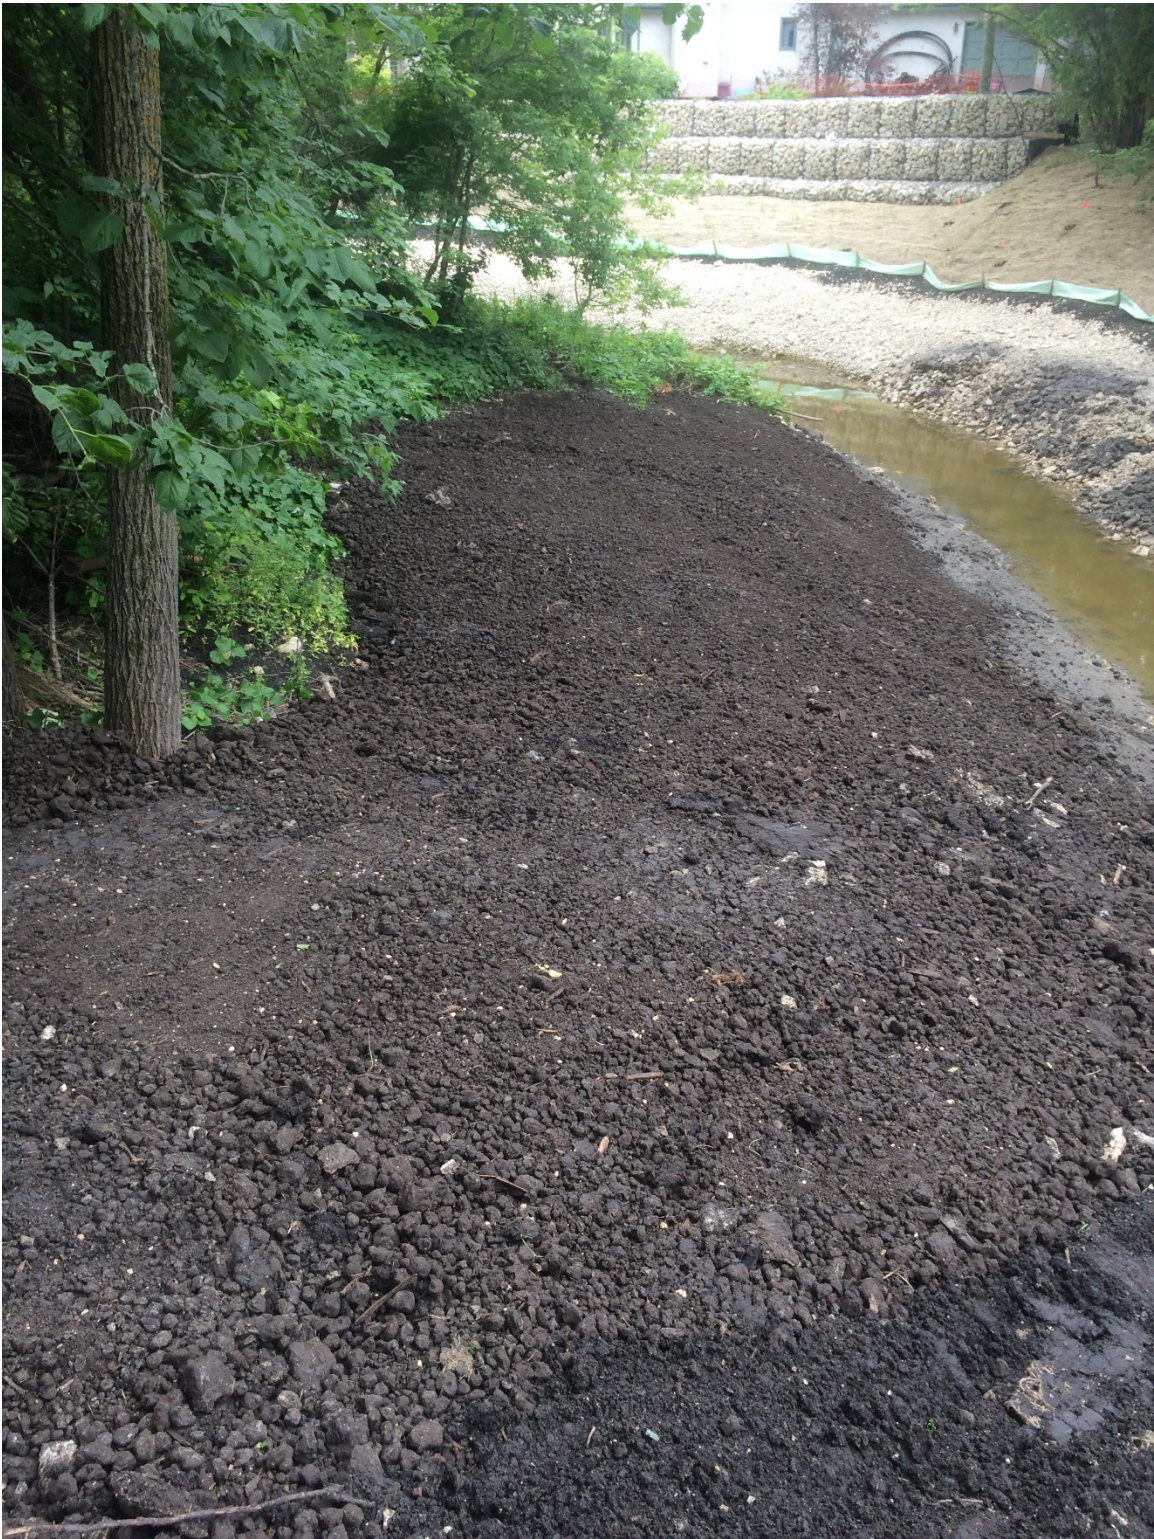
**Photo 3 - Topsoil placed on rockfill toe and area required to remediate at 3154 Henderson Highway.**

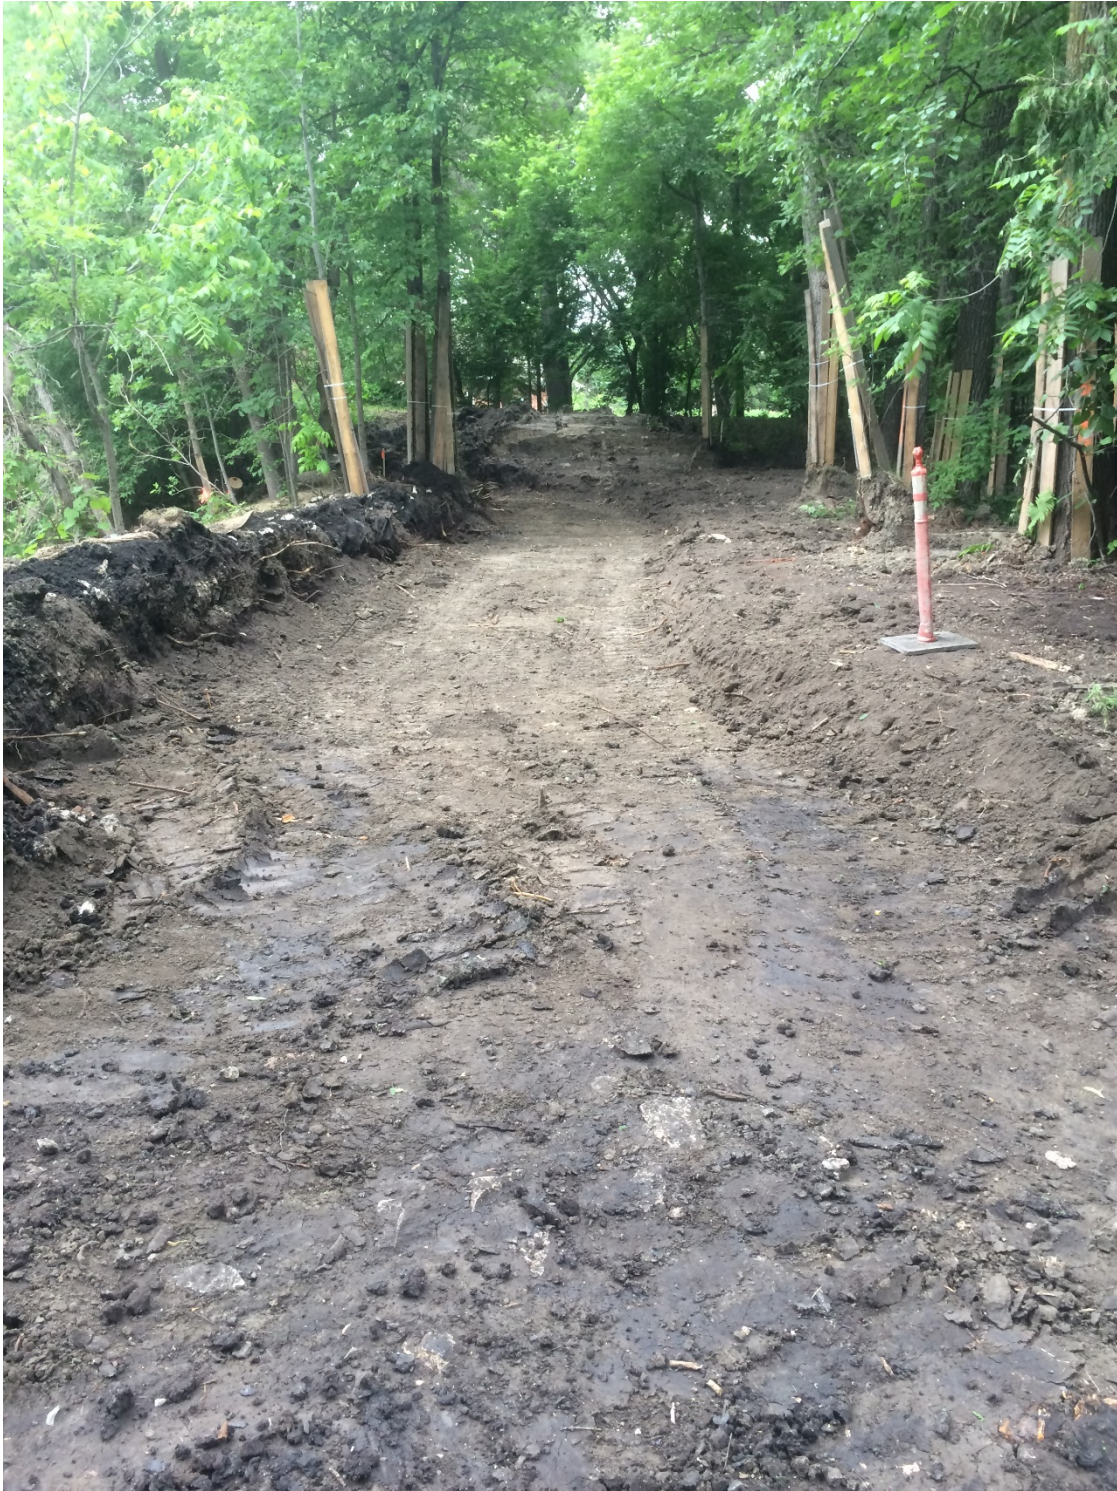
**Photo 4 - Existing dike and organic material below existing dike removed at 3154 Henderson Highway.**

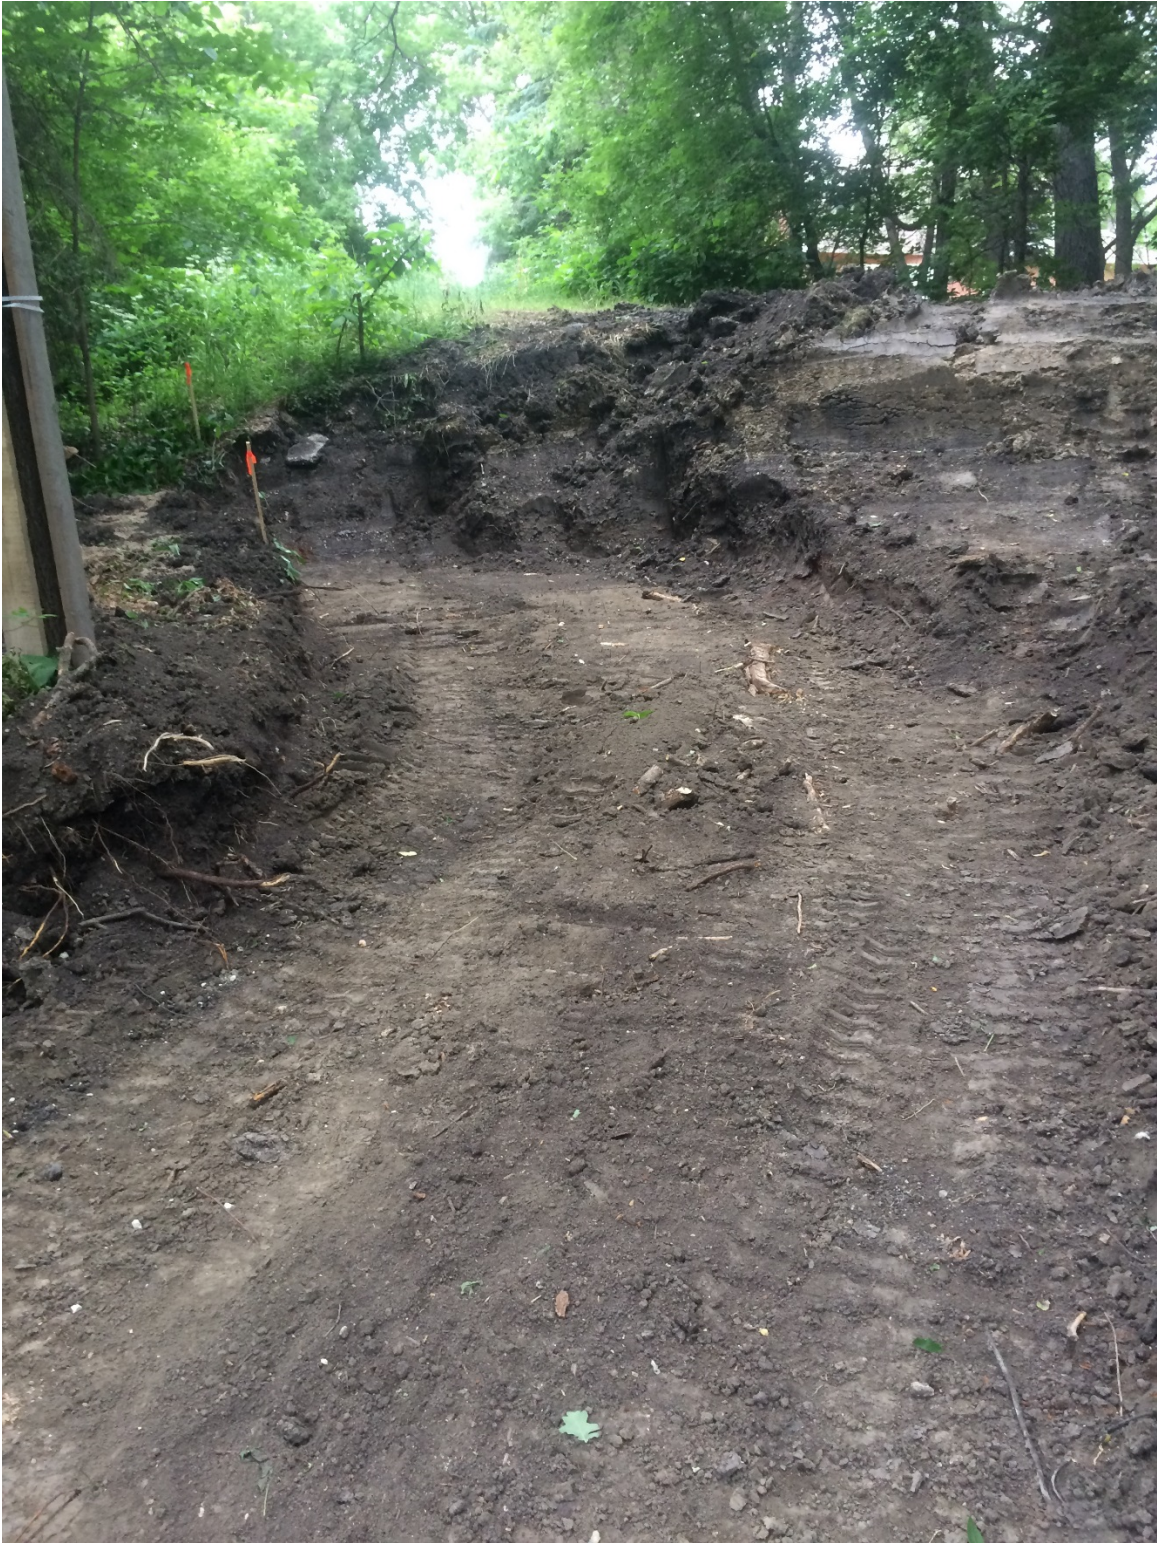
**Photo 5 - Existing dike and organic material below existing dike removed at 3154 Henderson Highway.**

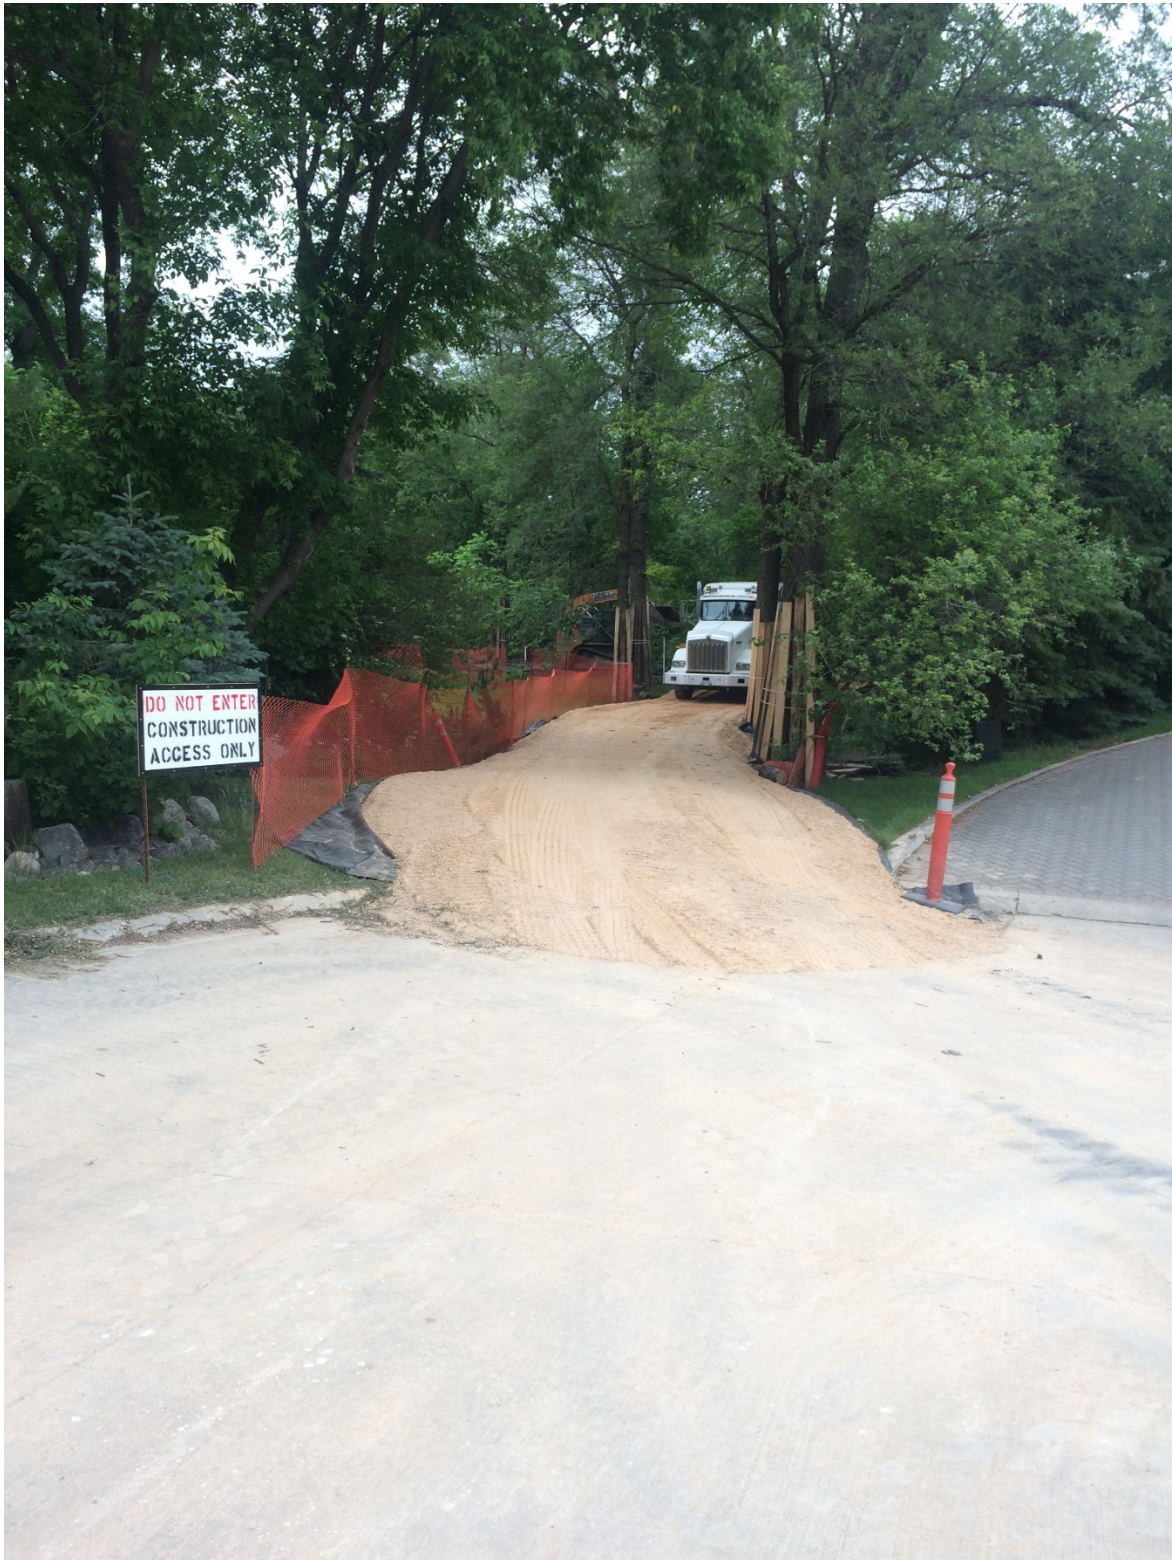
Photo 6 - Access road between 1030 and 1040 Highland Park Drive.

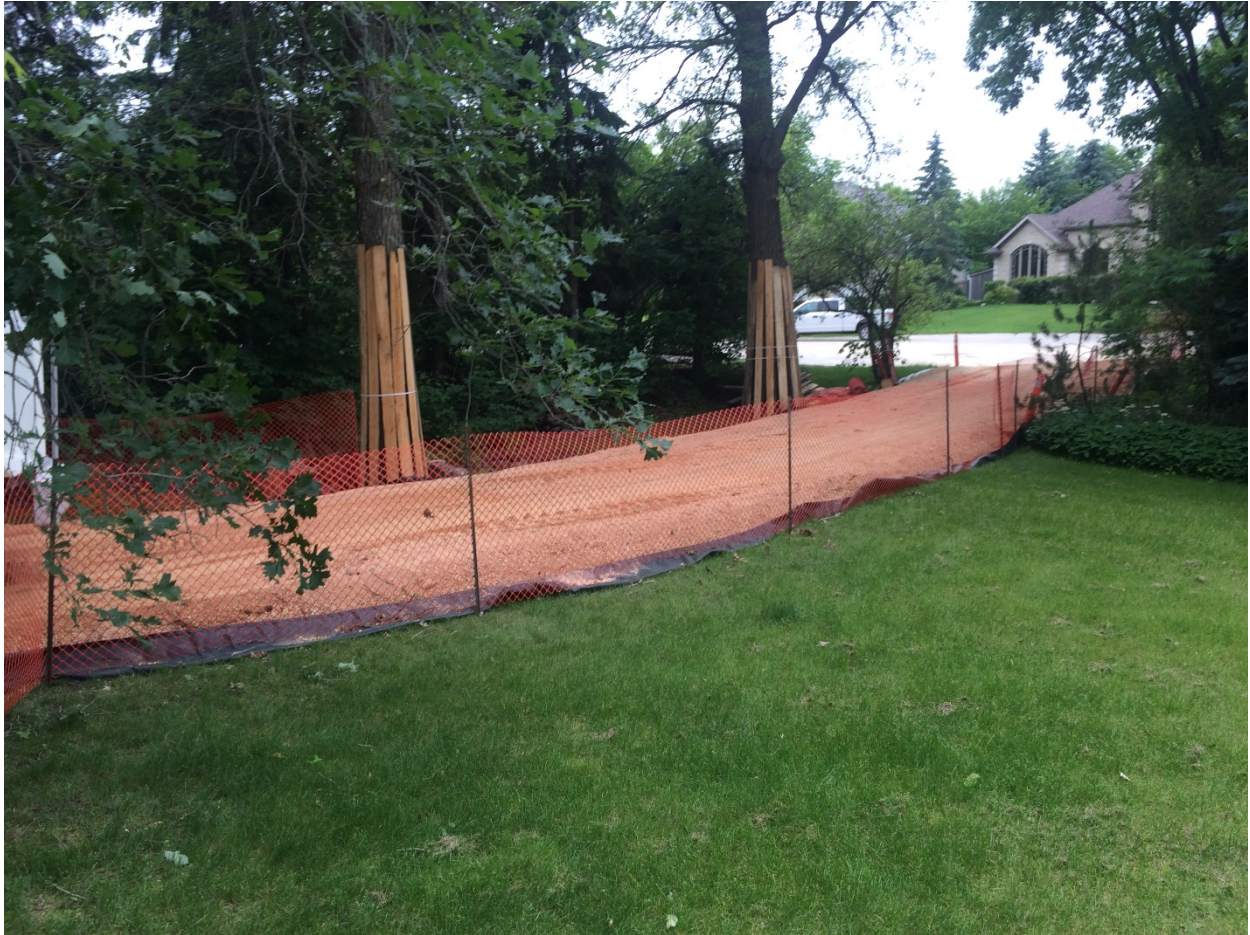
**Photo 7 - Access road between 1030 and 1040 Highland Park Drive.**

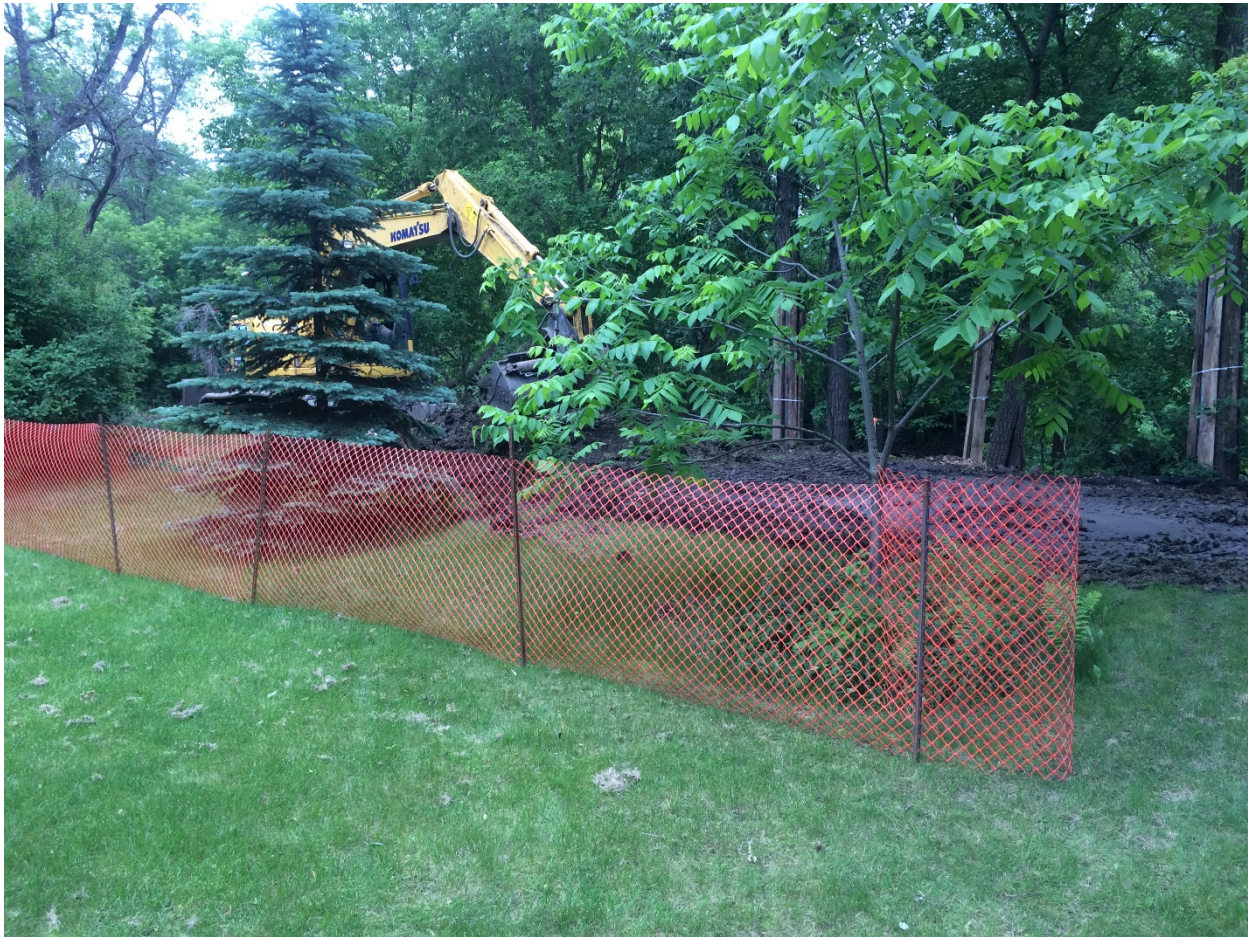
**Photo 8 - Removal of organic material from existing dike at 1040 Highland Park Drive.**

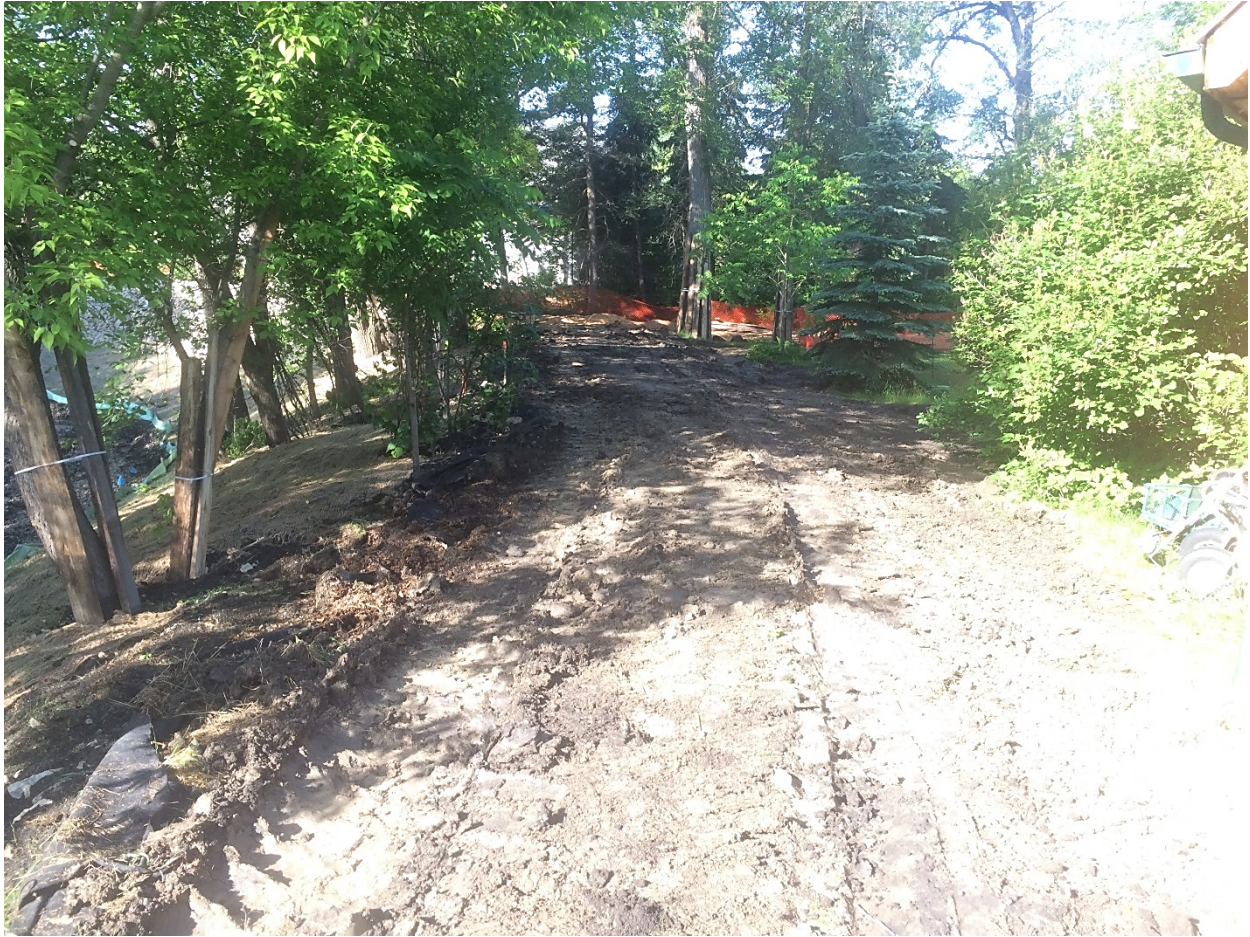
**Photo 9 - Organic material removed from existing dike at 1040 Highland Park Drive.**

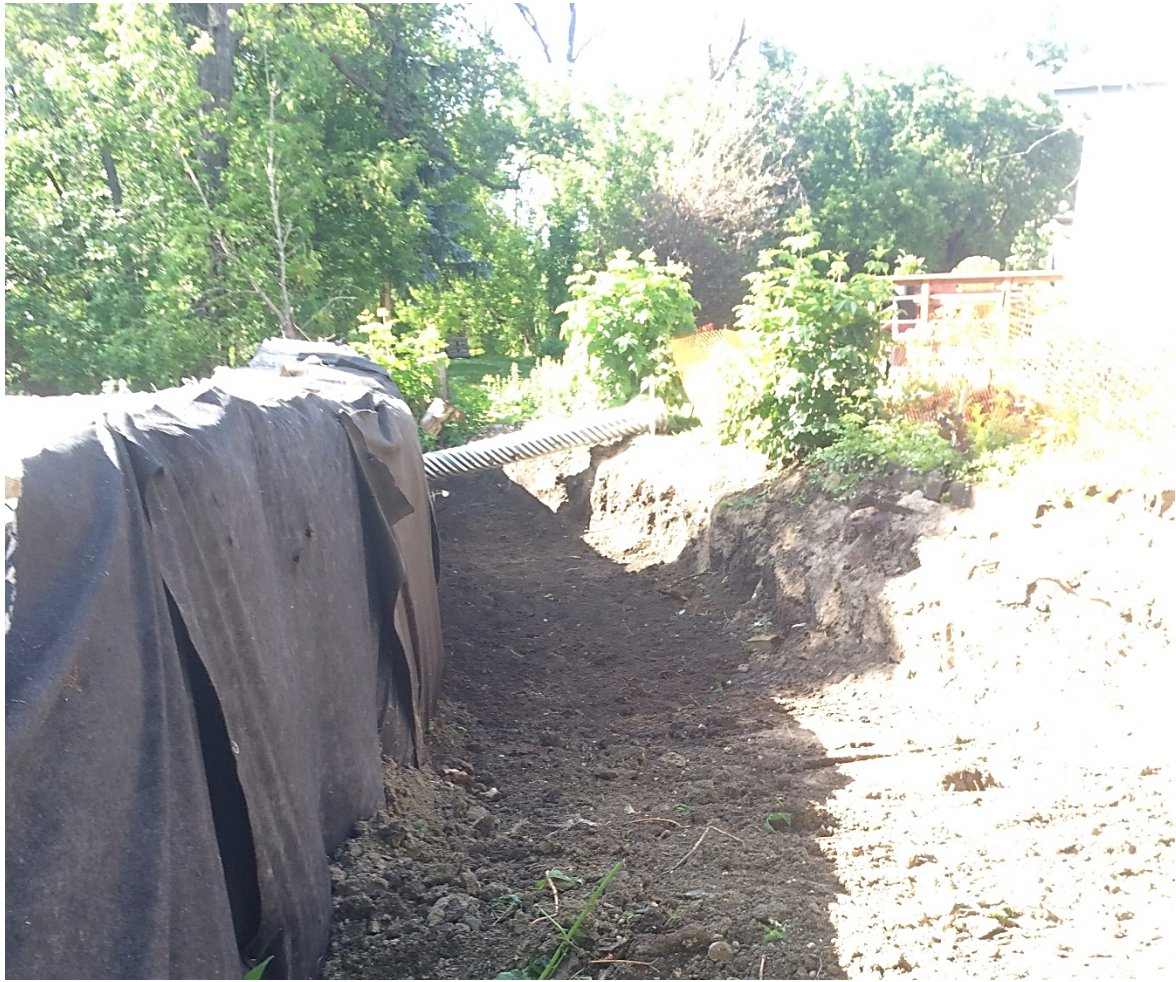
**Photo 10 - Organic material removed and clay fill placed behind gabion baskets at 1030 Highland Park Drive.**

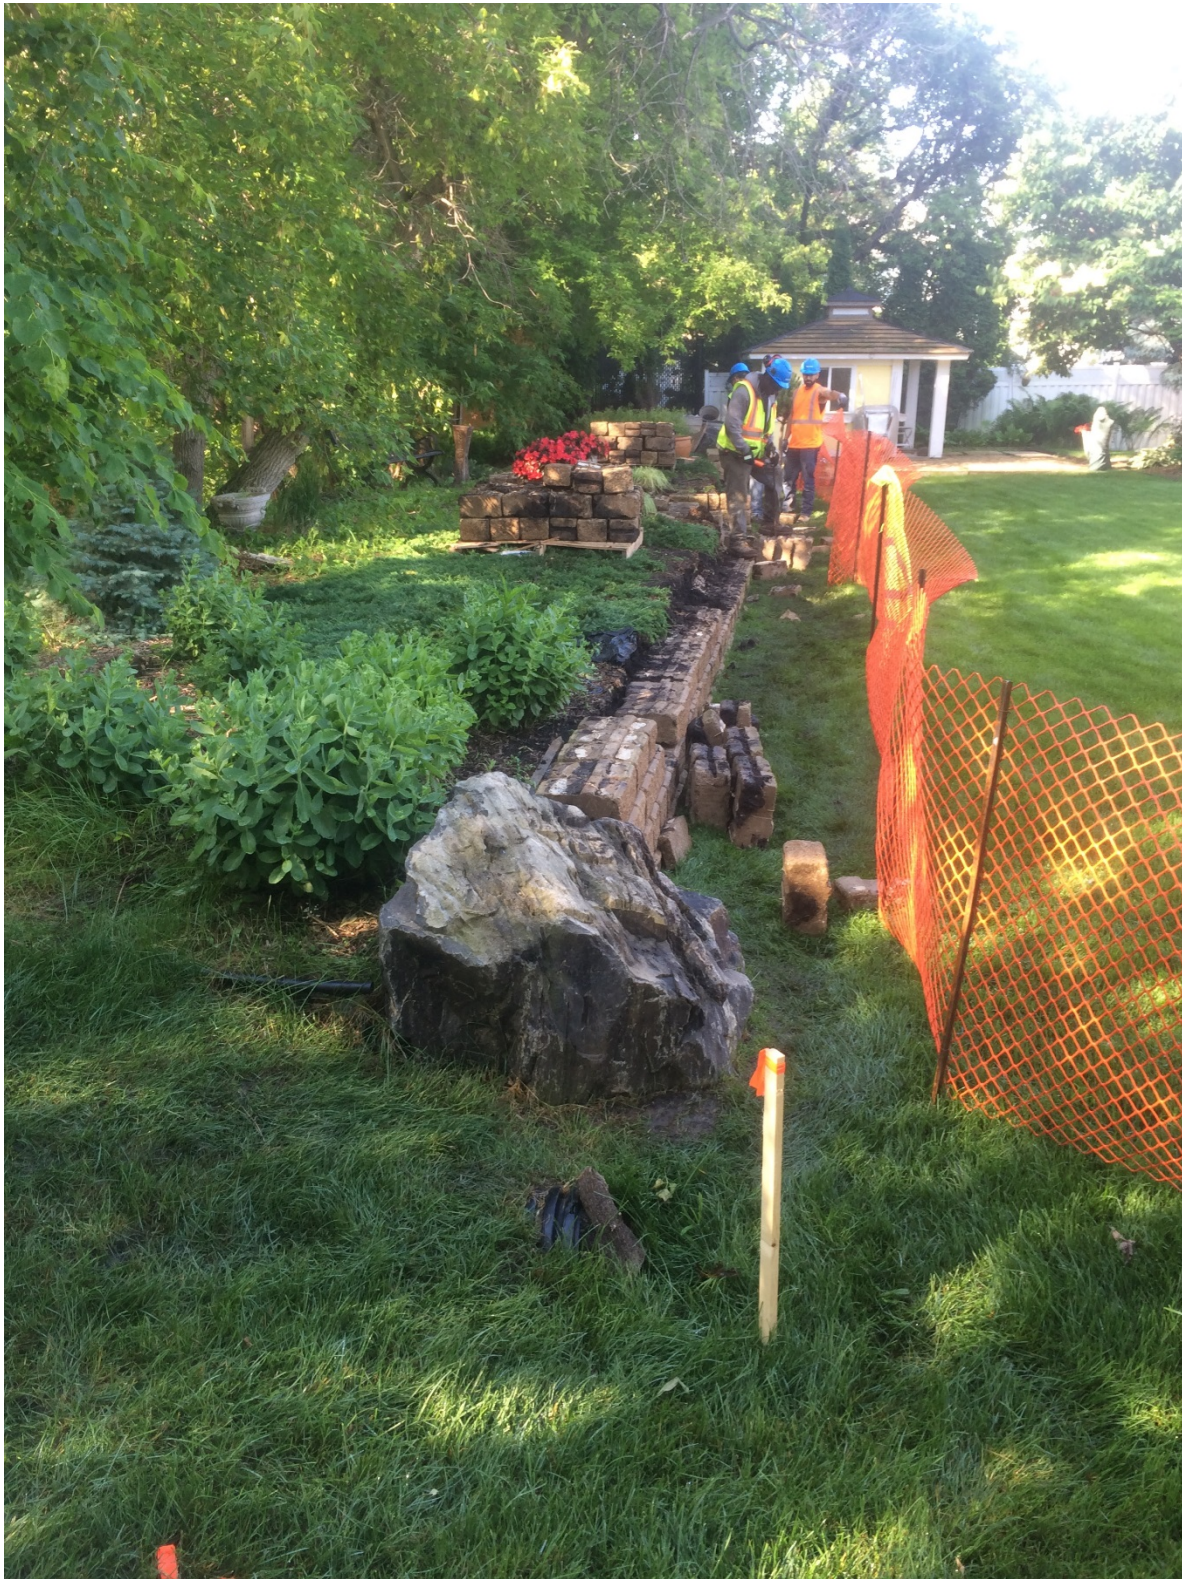
**Photo 11 - Removal of the existing segmental block wall at 1020 Highland Park Drive.**

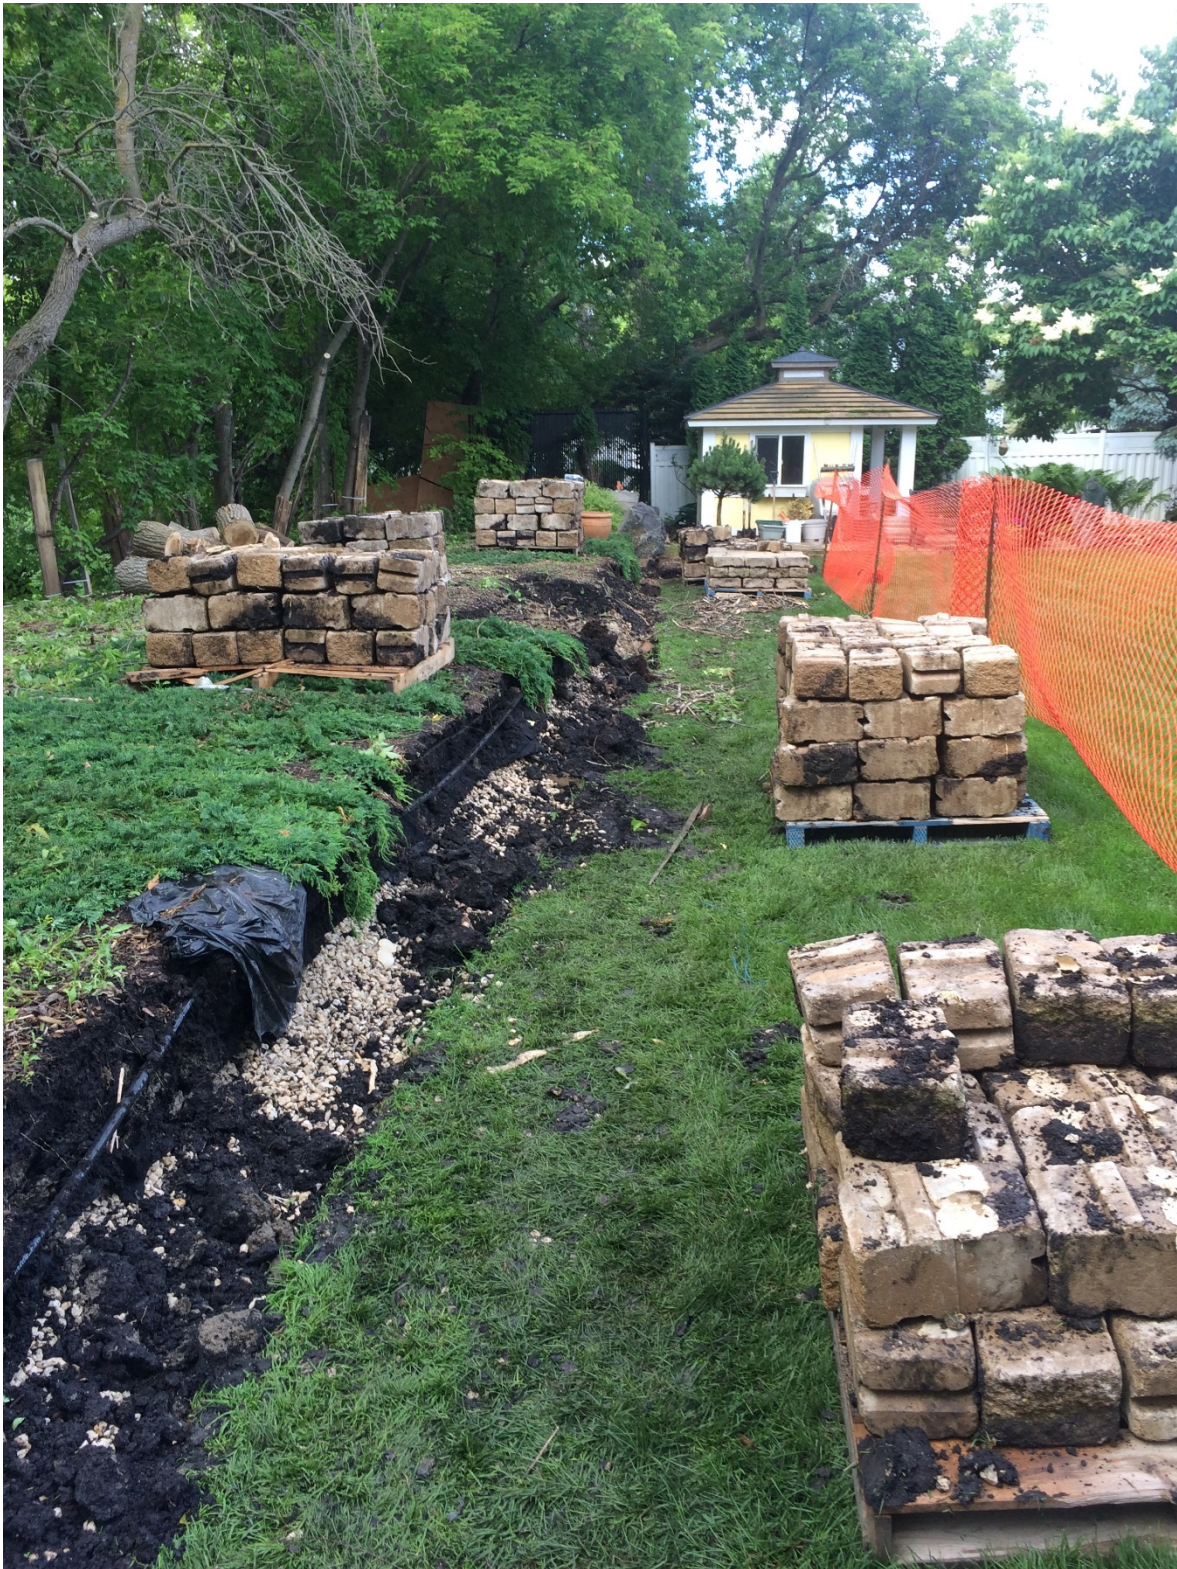
**Photo 12 - Removal of the existing segmental block wall at 1020 Highland Park Drive.**
